ARCHITECTURAL ANALYSIS OF THE RECONSTRUCTED BUILDINGS ENTRANCE UNITS OF KYIV HISTORIC CENTRE

***Abstract:** positive and negative issues in modern entrance groups in Kiev of the late 19th and early 20th century were considered. Four main types of entrance groups and their most typical elements were identified. Search of the possible ways to preserve the integrity of heritage buildings.*

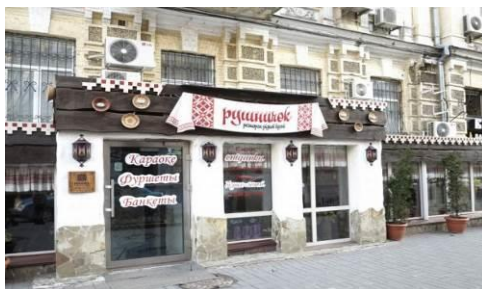
Fig.1. Entrance units of the “Rushnychok” restaurant.

Entrance units of Ukrainian cuisine restaurant “Rushnychok” on the Pushkin street, 25A (Fig.1) depart from the plane of the facade walls by means of enclosure and a shallow vestibule. Successfully used elements of Ukrainian embroidery, ornaments, pottery, together with the selected materials in the decoration, complement well to the integrity of the design decision of an institution, but only if taken separately from the facade. This is a positive example of color solution, but also a negative example of inconsistent separability of the first floor facades general structure. Entrance units and institutions shop windows are out of scale relatively to the proportional and metro-rhythmic facade construction.

2. – Volumetric entrance units (external tambour) retreating from the plane of the wall usually by 1-2 meters of closed internal space (Fig.1, 6, 7);

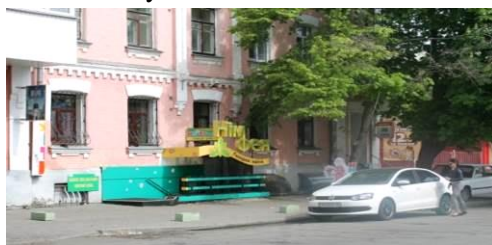
Fig.2. Entrance units of the “Nimphieia” cafe.

The entrance units of “Nimpheia” cafe on the Spasska street 11 (Fig.2) depart from the plane of the facade and also include stairs into the basement. This is an example of quite an unfortunate design decision, because it does not meet the facade by color, shape or scale, not even by style. The advertising sign is posted poorly; it shuts the half of the window and spoils the overall composition of the facade. The size and nature of letters does not match the scale of the facade.

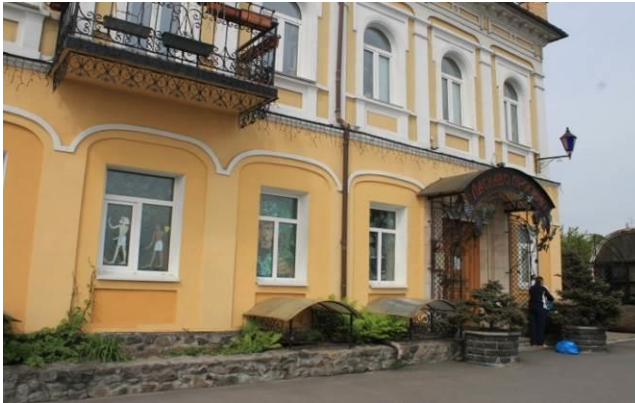
Fig.3. Entrance units of “Masandra” shop.

Entrance units of “Massandra” shop on Naberezhno-Khreschatytska street 19/21 (Fig.3) includes a canopy with forged decorative consoles – an example of successful usage of forged elements which repeat the decorative metal-plastic facade motif (in this case the decorative motif of balcony railings). The circular form symbolizing the sun and the arched shapes can be traced in the window, canopy and decoration of the facade decisions, which are decorated with a metric number of rounded, wavy elements above the windows. Forged canopies are the most common elements in Kyiv entrance units’ design.

3. – Entrance units with canopy (often with consoles) with partially opened space in front of the door (Fig.3) retreating from the plane of the wall mostly by 0,7-1,5 meters;

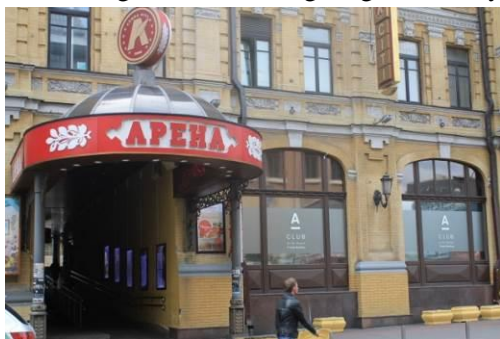
Fig.4. Entrance units of the “Arena” club.

The entrance units’ decision on the Chervonoarmiiska/Baseina street 3/2 (Pic.4) follows the Kyiv characteristic iron canopies on columns. The molded ornaments that resonate with plaster facade decorations are used here. The dome form resembles a semicircle

shop windows on the first floor. But the color of signs, its decor, letters size, logo and shiny dome material do not meet the general concept of the building and look more like kitsch.

4. – Entrance units carried out by the columns, with an open passage space beneath it (Fig.4, 9) retreating from the plane walls by 2-4 meters.

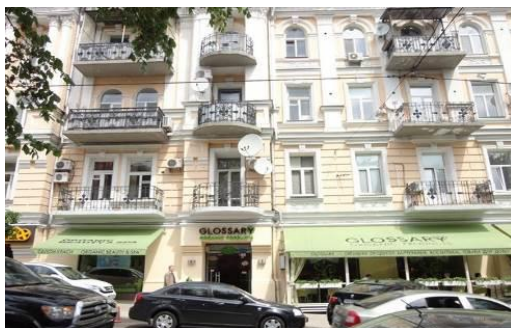
Fig.5. Entrance units of the beauty parlor.

Entrance units of the beauty parlor at Volodymyrska street 40/2 (Fig.5) has no permanent building additions, modern materials and simple, light constructions “marquee” are used, they can be easily removed, but large shop windows violate the proportionate and metro-rhythmic structure of the facade. The font and the emblem of the institution, as well as the colors are successfully chosen. Light green along with the contrasting black color with white and beige colors of the building and contrasting forged balcony railings.

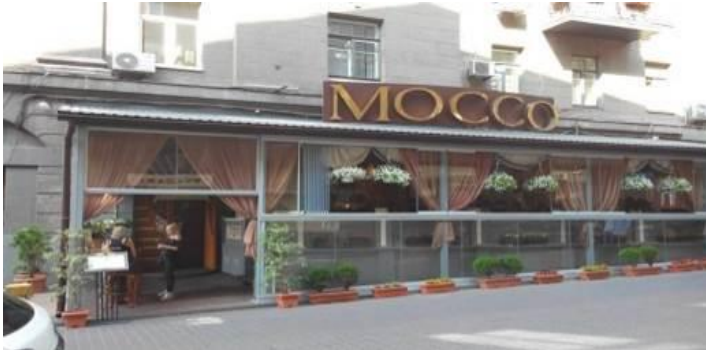
Fig.6. Entrance units of the “Mocco” restaurant

The restaurant on the Khreshchatyk street 15/4 has entrance units resolved in the form of rectangular vestibule slightly retreating from

the plane of the wall. But its proportions, scale and division do not correspond to the structural organization of the facade. Signs and font size are too large (Fig.6).

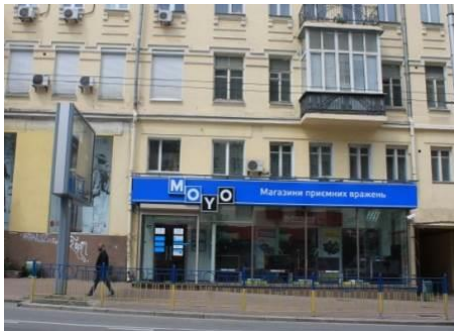
Fig.7. Entrance units of the electronics shop.

Entrance units in electronics store on Saksaganskogo street 16/43 (Fig.7) – do not meet either the scale or style of the building, the sign is of bright blue color not suiting the delicate pastel tones of the facade. The proportions and separability of the entrance units violate the proportional and metro-rhythmic organization of facade.

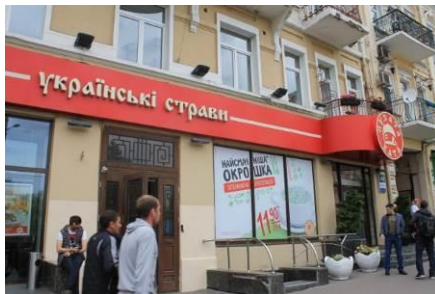
Fig.8. Entrance units of the catering facilities.

The main element of the entrance units of catering facility on the Chervonoarmiiska street 40 (Fig.8) is the canopy with the balcony on it, decorated according to the logo name. The windows of the first floor, advertising and the sign are out of scale to the elements of the facade building. The beige color of the logo repeats the color of the facade, but the bright red color is too contrasting, in the result the huge red sign crosses the facade and spoils the impression of the building.

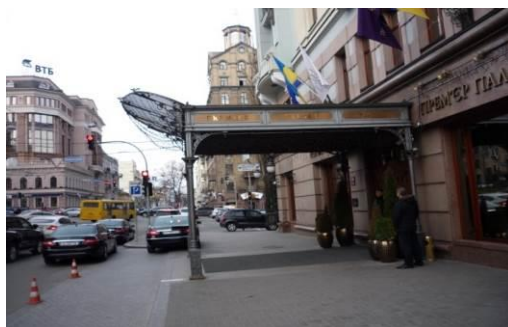
Fig.9. Entrance units of "Premier palace" hotel.

The entrance units of "Premier Palace" hotel, which are situated on the Pushkinska street (Fig.9), look pretty presentable. The main accent element here is a characteristic for old Kyiv canopy carried out on the entire width of the sidewalk with molten metal pillars and an opened passage space underneath it. Proportions, color,

architectural and artistic decisions are consistent with the composition of the facade and the environment.
