Mikhail Karuskevich, Prof.

FATIGUE LIFE PREDICTION BY THE STRUCTURALLY SENSITIVE DAMAGE INDICATOR

National Aviation University
E-mail: mkaruskevich@hotmail.com

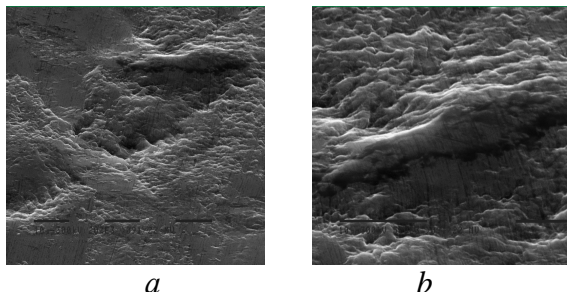
Fig. 1. Deformation relief at the investigation at different angles of observation and different enlargements:

a – x 2020;

b – x 5000

The three-dimensional character of observed pattern and its correspondence to the known scheme of intrusions and extrusions formation (fig.1, 2) have been confirmed by means of Scanning Electron Microscopy (SEM) investigation by using microscope Zeiss DSM950.

As it is seen from the fig. 1 the same objects reveal new features at different angles of the observation. The specimen presented on the fig. 1, 2 was tested under the maximum stress level 231,1 MPa, stress ratio $R = 0$ and frequency 11Hz.

The number of cycles applied to the specimen is $N = 10^5$.

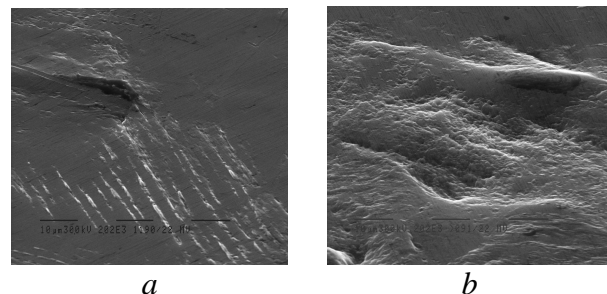
Fig. 2. Structural components

of the deformation relief:

a – persistent slip bands;

b – extrusions and intrusions

The fig. 2 reveals typical structural components of the deformation relief, namely: extrusions, intrusions, persistent slip bands.

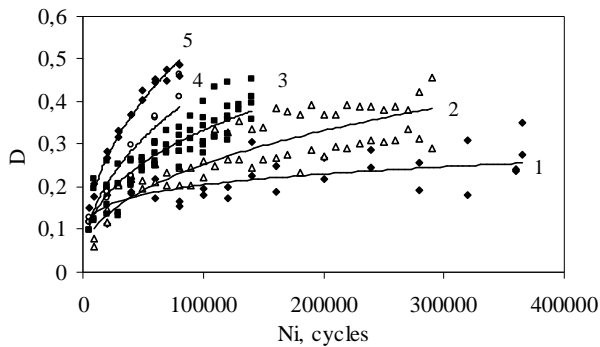
Fig. 3. Evolution of damage parameter D on the surface of alclad aluminum alloy D16AT under cyclic loading:

- 1 – $\sigma_{\max}=76,9$ MPa;
- 2 – $\sigma_{\max}=81,7$ MPa;
- 3 – $\sigma_{\max}=96,2$ MPa;
- 4 – $\sigma_{\max}=115,4$ MPa;
- 5 – $\sigma_{\max}=134,6$ MPa

As an example the result of fatigue test of D16AT specimens and damage monitoring under axial tension with the maximum stress of 76,9 MPa; 81,7 MPa; 96,2 MPa; 105,8 MPa; 115,4 MPa; 129,8 MPa, 134,6 MPa and stress ratio $R = 0$ and frequency are presented.

It expresses the relationship between the damage parameter D and current number of cycles N_i (fig. 3).

The tests were stopped after the nucleation of 1,0 mm fatigue crack as it has been considered as the critical state condition.

The investigation of deformation relief evolution under different maximum stresses shows the sensitivity of damage parameter to the value of the maximum stress level.

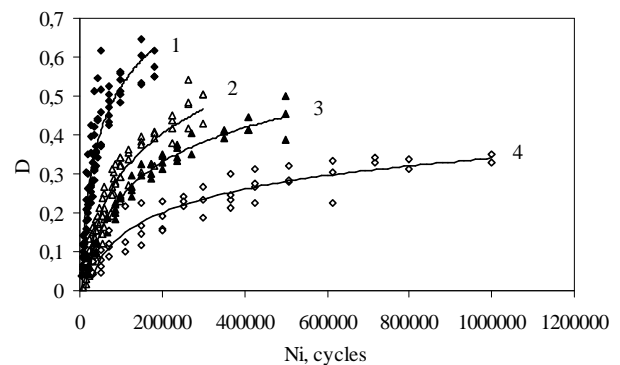
Fig. 4. Evolution of damage parameter D during asymmetrical loading process under stress ratio:

- 1 – $R = 0$;
- 2 – $R = 0,42$;
- 3 – $R = 0,5$;
- 4 – $R = 0,6$

Fig. 4 shows the evolutions of damage parameter D under the loading process of specimens, tested by bending under the maximum stress of the cycle $\sigma_{\max} = 234,5$ MPa and the different stress ratio R .

The results presented on fig. 4 prove the sensitivity of parameters of deformation relief to the stress ratio.

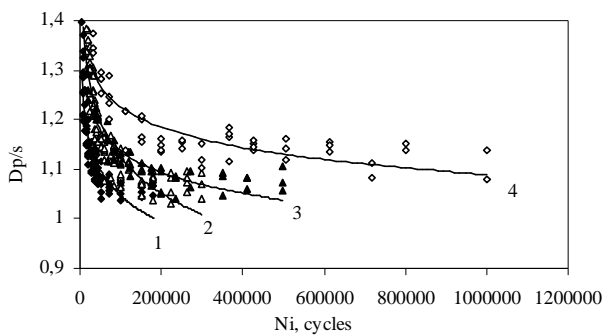
Fig. 5. Relationship between the fractal dimension Dp/s and number of cycles under stress ratio:

- 1 – $R = 0$;
- 2 – $R = 0,42$;
- 3 – $R = 0,5$;
- 4 – $R = 0,6$

The fractal dimension $D_{p/s}$ appears to be most informative parameter of the surface relief patterns shape. Typical plot illustrating relationship between the fractal dimension $D_{p/s}$ and number of cycles presented on fig. 5.

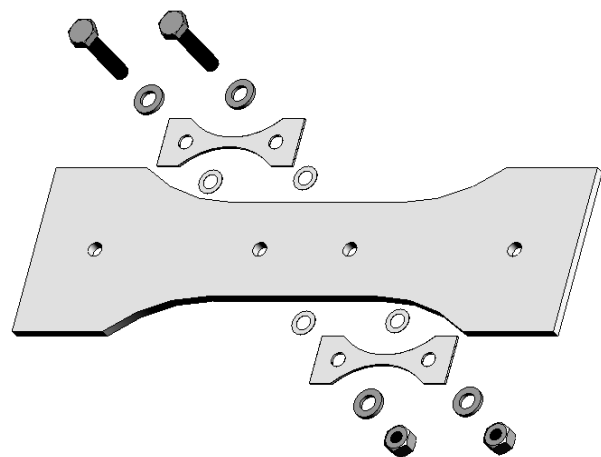
Fig. 6. 3D image of the sensor attachment to the specimen for fatigue test

The attachment of the indicator to the specimen (fig. 6) for fatigue tests and their team-work under cyclic loading has been also simulated.

In the mentioned tests the sensors were installed on each side of structural components. Thereby such scheme helps to provide the symmetrical loading of the sensors and to receive more information about their damage.
